This information is designed to help you better understand the hurricane mitigation credits given on the OIR B1-1802 form for residential homes.

The Purpose of Mitigating Homes

HURRICANE MITIGATION

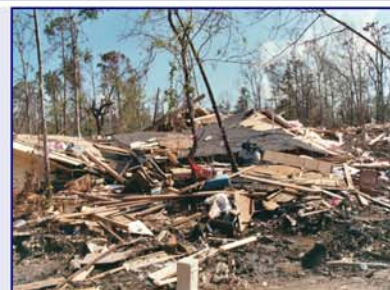
Without mitigation techniques applied, your home may not withstand a wind-storm as well as you think it will!

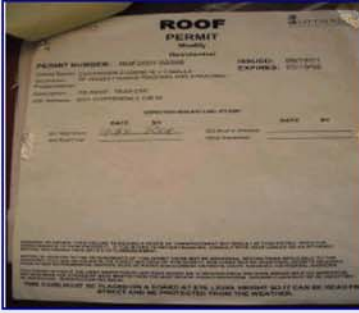
Roof Covering and Installation Date

If you believe you have a newer roof or the dates of installation are around 1995 or 2002, inspectors must verify the month installed typically by checking the permit application date.

The most important and frequently overlooked element that governs the losses experienced in hurricanes is the roof covering.

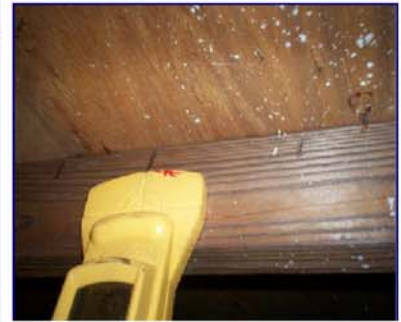
A metal detector is used to determine the nail spacing along the trusses.

The inspector will look for the thickness of roof sheathing, the type of attachment (staple, nail or screw), the size of the nail, and the spacing of those nails. Depending upon the combina-

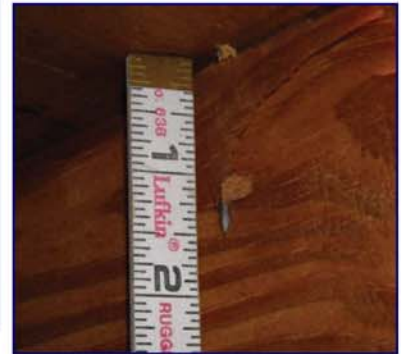
The inspector measures shiners to determine the nail size.

type. Typically they will find a "shiner" and take a photo next to a measurement device showing the size of the nail. The inspector will also mark the truss showing the attachment spacing. If no photos are present showing these details, your report may be questioned as to its validity.

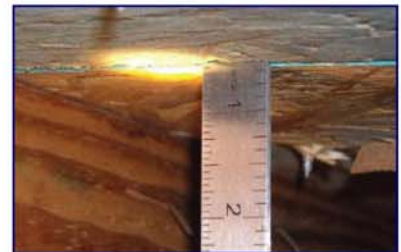
Finally, the sheathing thickness is measured. Once the inspector has these pieces of information, question 2 of the OIR 1802 can be answered.

tion of the items listed, the strength of the roof deck attachment can be determined. When you receive your mitigation report, the inspector will show photographs of the sheathing thickness measured with a ruler or other measurement device.

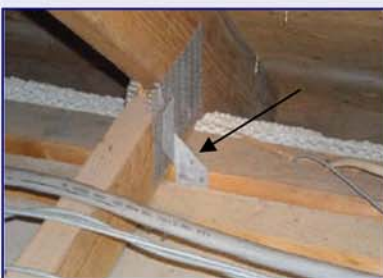
This photo shows clips as the roof to wall attachment.

This photo shows a single wrap as the roof to wall connection.

Single wraps are very common, but from a wind mitigation perspective, often installed incorrectly. In order to be considered single wrap for the roof to wall connection, the strap should be embedded into the top plate of the wall, should have at least three nails into the truss on one side and then

wrap over the top of the truss and be nailed to the other side with at least one nail. If that one nail is missing from the other side, it should be marked. Clips, though the photos may look like single wraps. (See photo Bottom Right for an example.)

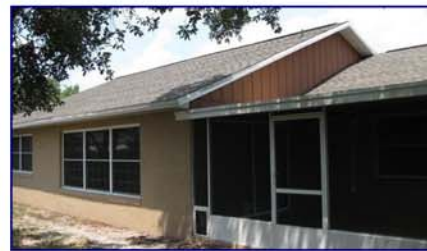
This home is classified as Other.

If there is one gable greater than 50% of an elevation or wall length, the ENTIRE ROOF is classified as Other. If the roof is all Hip except for a flat portion over a porch that is structurally connected to the roof system, the ENTIRE ROOF is classified as Other.

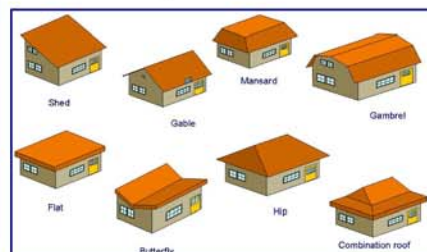
The diagram above shows multiple roof shapes.

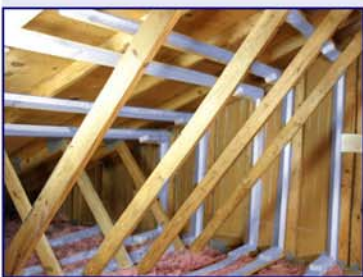
This photo shows one form of bracing called horizontal or continuous gable bracing (white boards).

In order to qualify a gable as braced, it must be braced to meet the 2001 FBC.

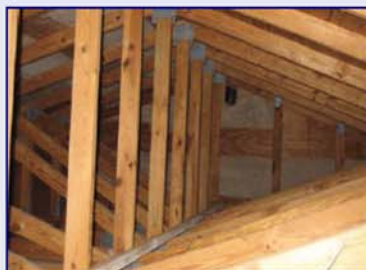
This is an example of 'Unbraced Gable End.'

Bracing that does not meet this code would be marked, Gable End(s) are NOT braced.

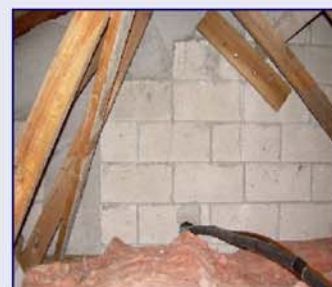
Reinforced masonry gable end.

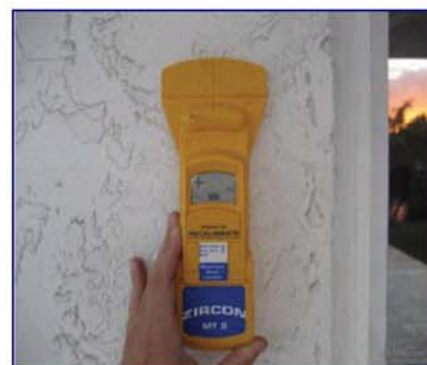
This photo shows the inspector validating the reinforcement in the walls with his metal detector.

For masonry walls, metal detectors are used to determine if the walls are properly

If Reinforced Masonry is selected, you should see a photo of the metal detector showing the reinforcement as validation, as this is used to identify the locations of reinforcement.

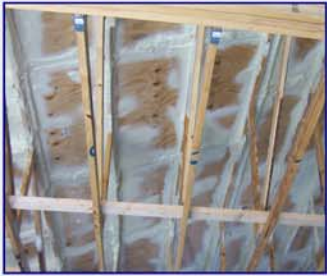
LEFT: A qualifying SWR for OIR 1802 purposes. Notice the seal is typically only along the joints.

RIGHT: A photo of foam insulation, which does NOT qualify as an SWR.

Many inspectors incorrectly complete this question because of this confusion. In order to qualify for an OIR SWR credit, you must have a self adhering modified bitumen roofing underlayment applied directly to the roof

sheathing or foam SWR sprayed from inside the attic (not spray foam insulation). If you live in Miami-Dade, your SWR must meet additional requirements.

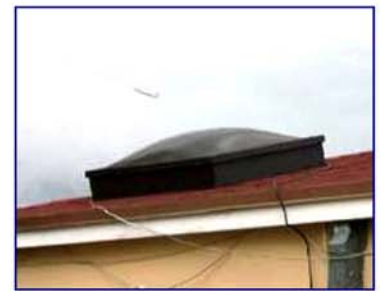
EVERY OPENING, including skylights and gable vents, must be protected in order to receive the Hurricane rating.

In order to receive the HURRICANE rating, EVERY opening on the home, including garage door, skylights and gable vents, MUST be protected with impact-resistant products that have been tested and comply with the codes

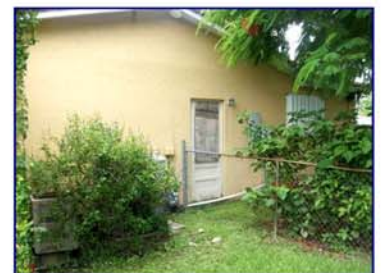
This home had every opening BUT this one protected. Because the glazing on this door is not protected with an impact resistant product, the ENTIRE home is classified as None.

If your garage door has glazing (small openings), your inspector will consider the entire home as rated "None" for the opening protection on the OIR 1802.

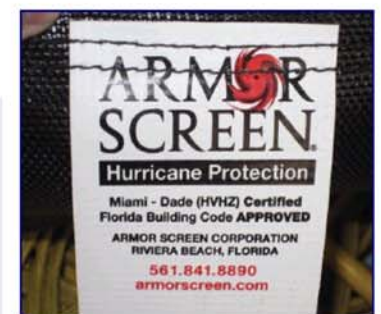
If you have Hurricane protection on EVERY opening, the inspector will verify the product and photograph the approval stickers or documentation in order to qualify your discount.
